PROJECT
IntegraRack
 TITLE
IR-T1 No Penetration TileBallast™ Solar Module Mounting System
 IR-T1TB1031

Subject: Compression, Horizontal, and Uplift Load Testing on the Universal L Foot Bracket (PN IR-DMLF2000) & IR-T1 No Penetration Tile Roof Bracket (IR-FCTR1500)

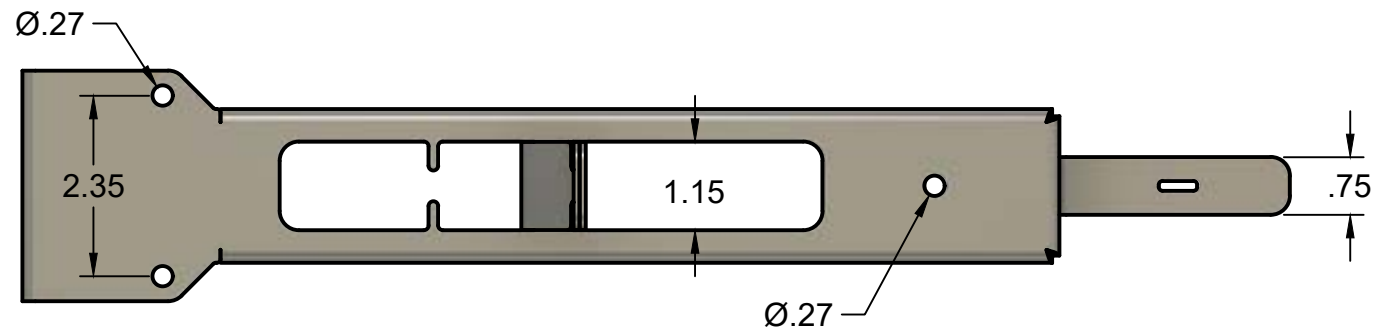
Top View

Back View

Side View

Maximum Solar Module Size		
24 SQFT		
IR-T1 Spacing For Rails	Maximum Wind Speed	Maximum Snow Load
One Mount Every 6 ft	120 MPH	10 LBS/SQFT
One Mount Every 4 ft	160 MPH	15 LBS/SQFT

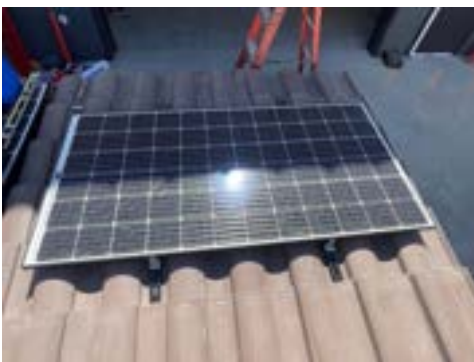
PHOTO 1: Overview of solar panel and tile roof deck - before tests

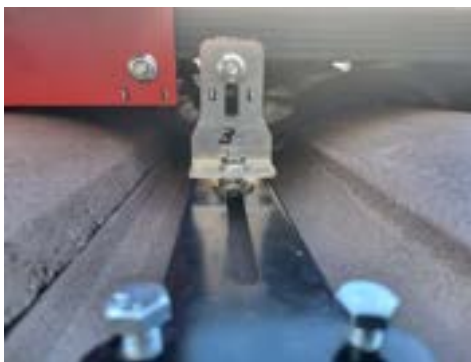
PHOTO 2: Typical Bracket - before tests

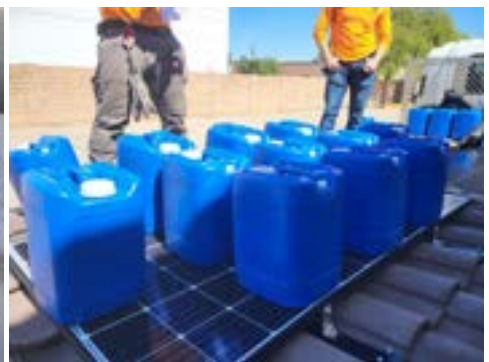
PHOTO 3: Load 1

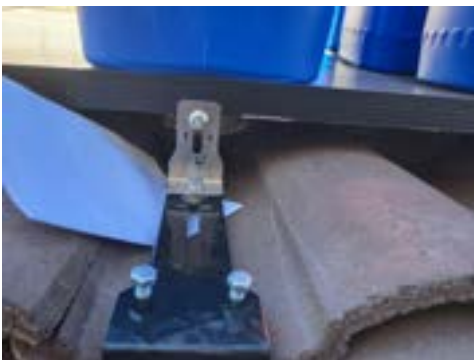
PHOTO 4: Load 1 - Bracket under load

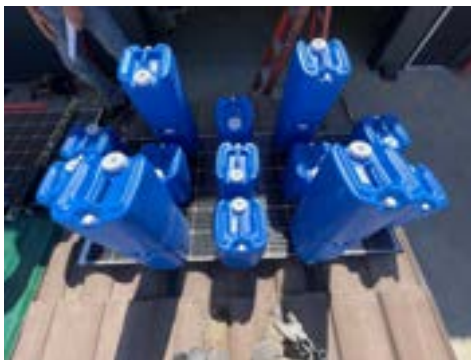
PHOTO 5: Load 2

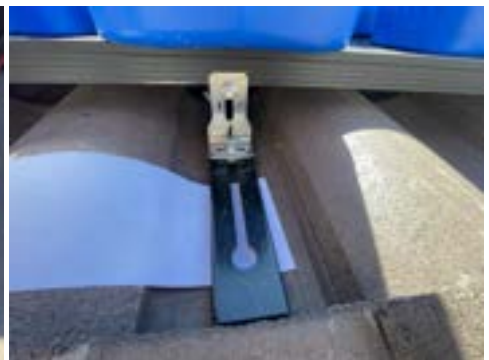
PHOTO 6: Load 2 - Bracket under load

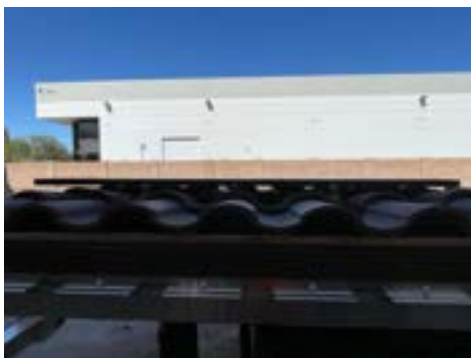
PHOTO 7: Unloaded - after tests

PHOTO 8: Unloaded - after tests

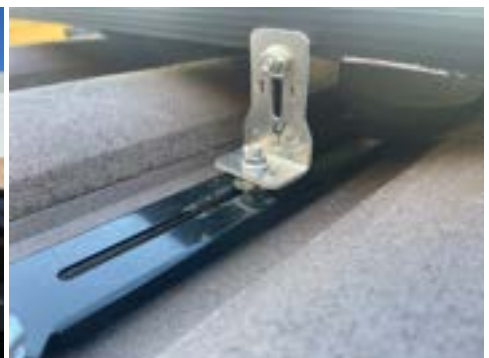
PHOTO 9: Unloaded Bracket - after tests

Note: Bracket photos are typical of all locations

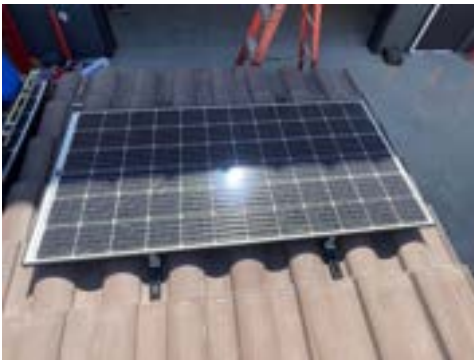
PHOTO 1: Overview of solar panel and tile roof deck - before tests

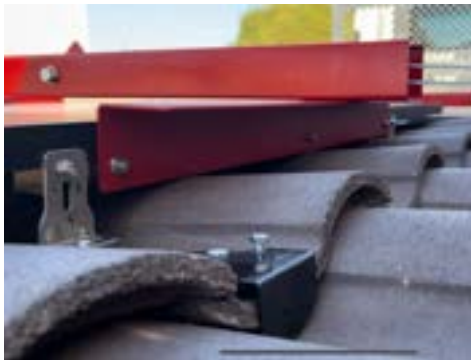
PHOTO 2: Bracket with no load

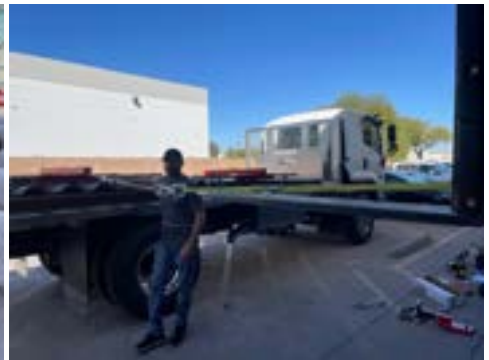
PHOTO 3: Test setup for horizontal pull load

The horizontal load test was conducted using a Weightronic Digital Dynamometer (Model OCS-Y) and chain hoist. A horizontal load of at least 500 lbf was applied at the center of the crossbeam that was attached to the panel brackets. The test specimen held the load and no damage or permanent deformation was noted as shown in the test observations table shown below.

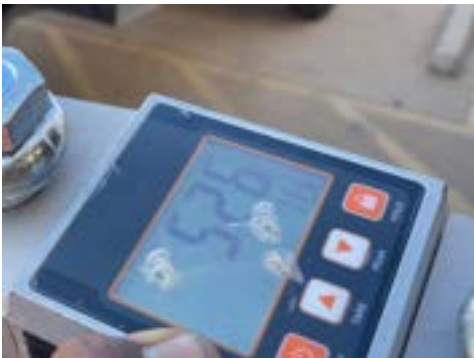
PHOTO 4: Applied load

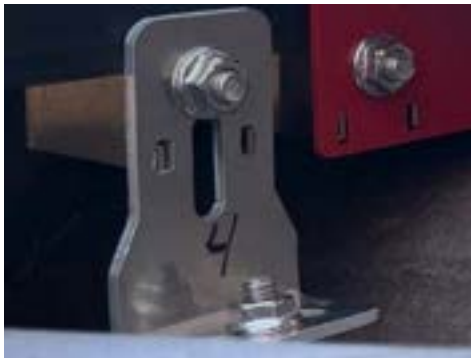
PHOTO 5: Bracket under load

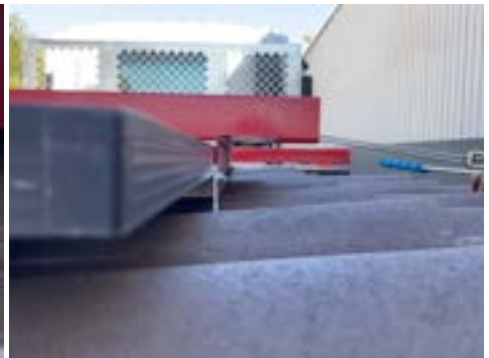
PHOTO 6: Test setup after test

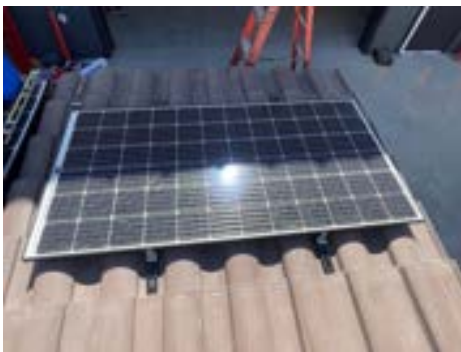
PHOTO 1: Overview of solar panel and tile roof deck - before tests

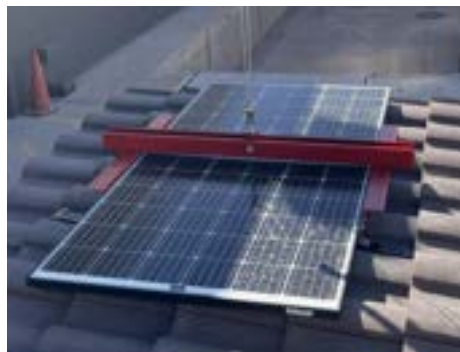
PHOTO 2: Overview of tensile test setup and connection

The uplift load test was conducted using a Weightronic Digital Dynamometer (Model OCS-Y) and chain hoist. An uplift load of 710 lbf, equivalent to a 33.08 psf uplift force evenly applied to the solar panels, was applied at the center of the crossbeam that was attached to the four panel brackets. The test specimen held the load and no damage or permanent deformation of the test brackets was noted as shown in the test observations table shown below.

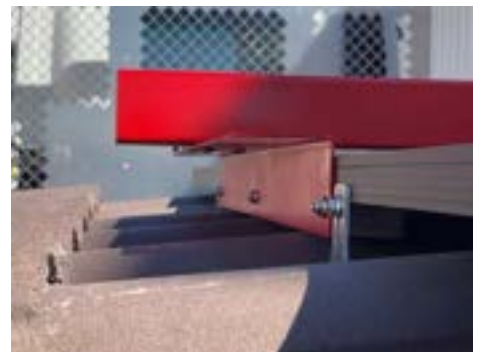
PHOTO 3: Brackets with no load

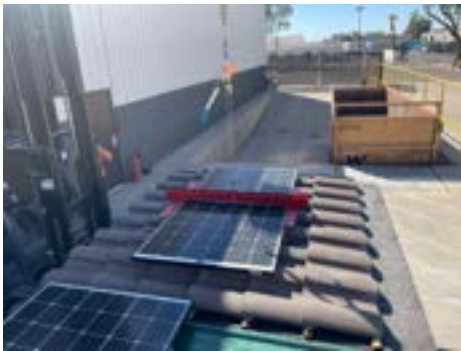
PHOTO 4: Test setup

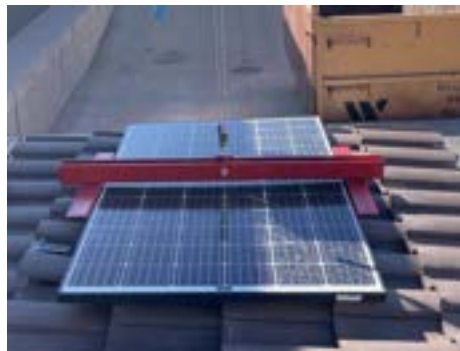
PHOTO 5: Test specimen while under tensile load

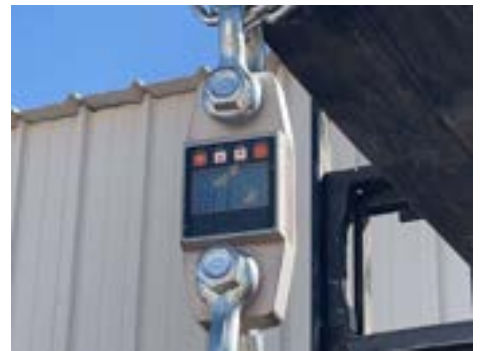
PHOTO 6: Dynamometer scale under load

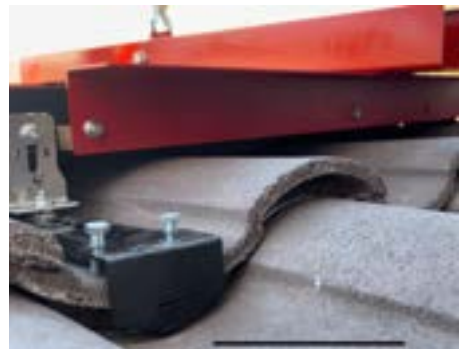
PHOTO 7: Bracket under test load

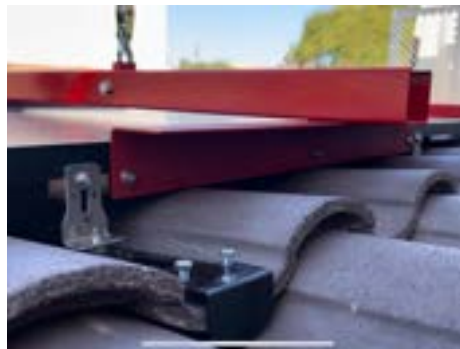
PHOTO 8: Bracket unloaded after test

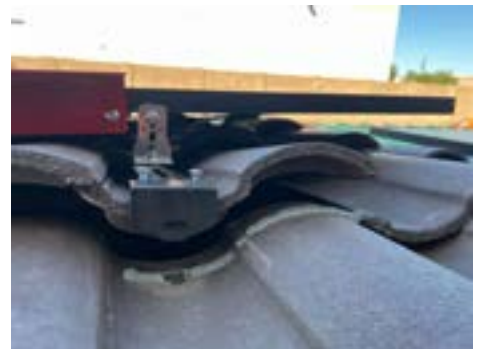
PHOTO 9: Bracket unloaded after test - roof tile bond pulled apart.

The solar panel did not show any signs of permanent damage or deformation.						
At Bracket No. 3, the tile roof shingle separated at the glue bond from the shingle underneath.
