Test Report

Report No.: SUER230900061471 Release date.....: 2023-10-12

Product Description.....: V-BOX-OC

Test Standard.....: IEC 60529:1989/AMD2:2013/COR1:2019 Degrees of protection provided by enclosures (IP Code)

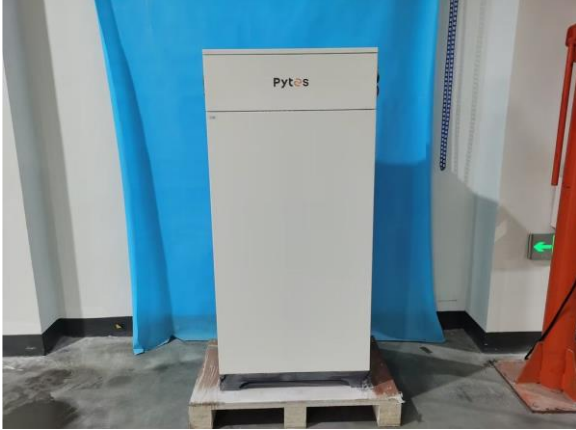
Before Test	After Test

Sample Number	Test Result
1#	After test, there is no dust inside.

Simulated dust	Talcum powder
Dust Usage	2 kg/m ³
Pumping	No
Test duration	8h

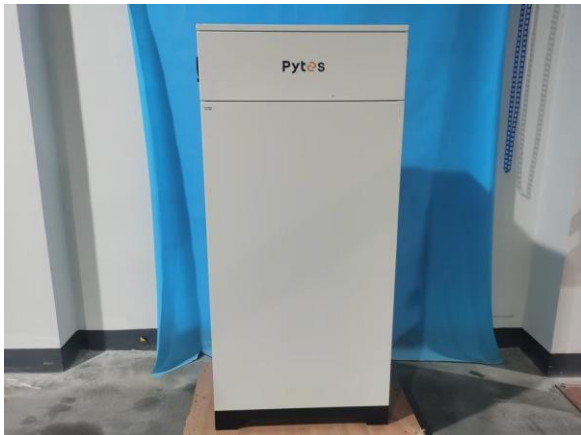
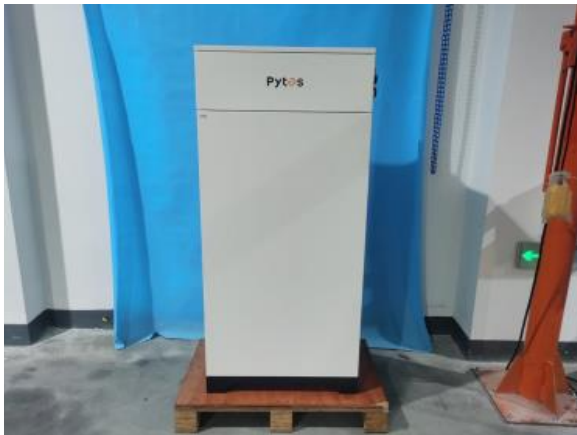
Before Test	After Test

Sample Number	Test Result
1#	After test, there is no water inside.

Water Flow	12.5(1±5%) L/min
Nozzle diameter	6.3 mm
Test Distance	2.5m~3m
Test duration	1 min per square meter calculated according to the surface of the sample shell, test for at least 3 min
